Reducing plastic shrinkage cracking in slabs

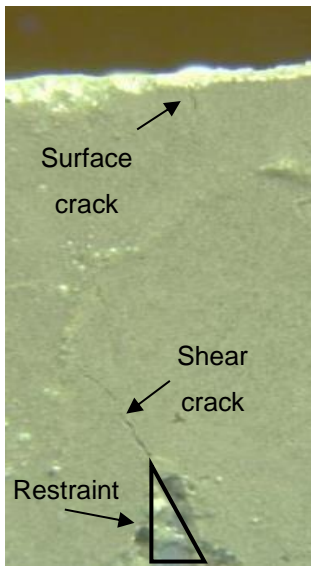
Figure 1. Plastic settlement cracks above restraint as viewed from the side

These cracks mainly occur in concrete elements with large exposed surfaces such as slabs, bridge decks and pavements. In most cases, plastic shrinkage cracks also interact with plastic settlement cracks. These cracks occur if the uniform settlement of solid particles in the fresh concrete mix is disrupted by inclusions such as reinforcing steel bars or a non-uniform slab depth. This results in differential settlement which causes both a shear and surface crack above the restraint as shown in the Figure 1. The surface crack is often only visible from the side and not at the surface, while the shear crack is only visible from the side. These cracks can therefore be present even if not visible at the surface and when present in combination with plastic shrinkage cracking can lead to sudden and severe cracking. Figure 2 shows the plastic shrinkage cracking that occurred when tested with and without a reinforcing steel

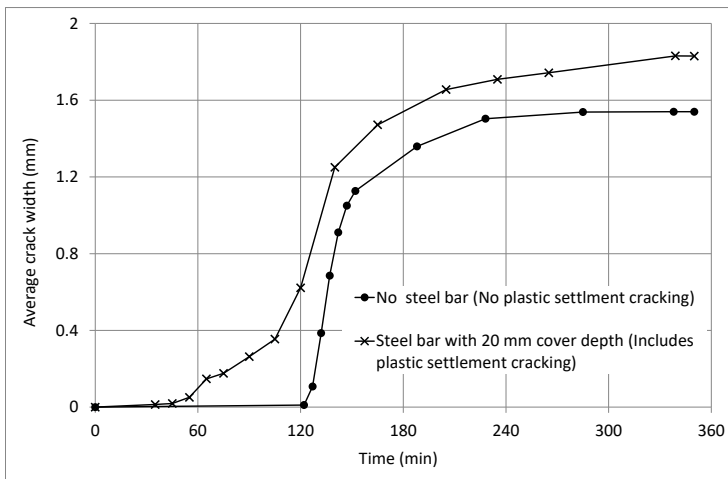
Figure 2. Crack widths without the influence of plastic settlement cracking

bar with a cover depth of 20 mm and therefore with and without the influence of plastic settlement cracking.

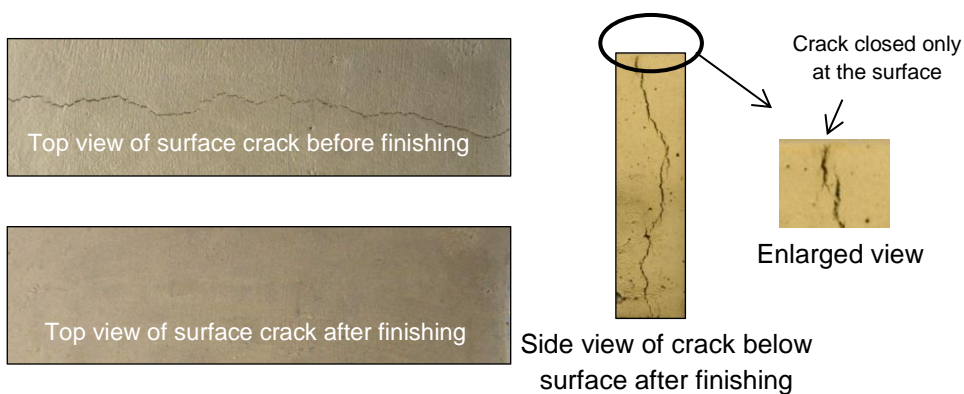
Figure 3. Influence of finishing operation on cracking

Preventing these plastic cracks remains a problem in practice due its complexity, even though there are several effective precautionary measures that can be taken. These measures are mostly external and aimed at reducing the water loss due to evaporation by for example using a fog spray above the concrete surface, applying a curing agent and even erecting sunshades and/or windbreaks. Although effective, these measures are often expensive, impractical and also difficult to apply at the appropriate time, especially for large slabs that are placed over several hours. Furthermore, these cracks are often hidden or closed at the surface due to finishing operations such as floating and trowelling as shown in Figure 3. The figure shows a plastic shrinkage crack that was closed at the surface by trowelling, while the crack remains present below the surface. This crack appears at the surface after a day or two, often leading to confusion regarding the origin of the crack due to its apparent appearance in the hardened concrete.
